DEPARTMENT OF THE ARMY
UNITED STATES ARMY AVIATION TEST BOARD
Fort Rucker, Alabama 36360

SUBJECT: Letter Report, "Product Improvement Test of T53-L-11
Engine," RDT&E Project No.
USATECOM Project No. 4-5-0101-01 and -06 ✓

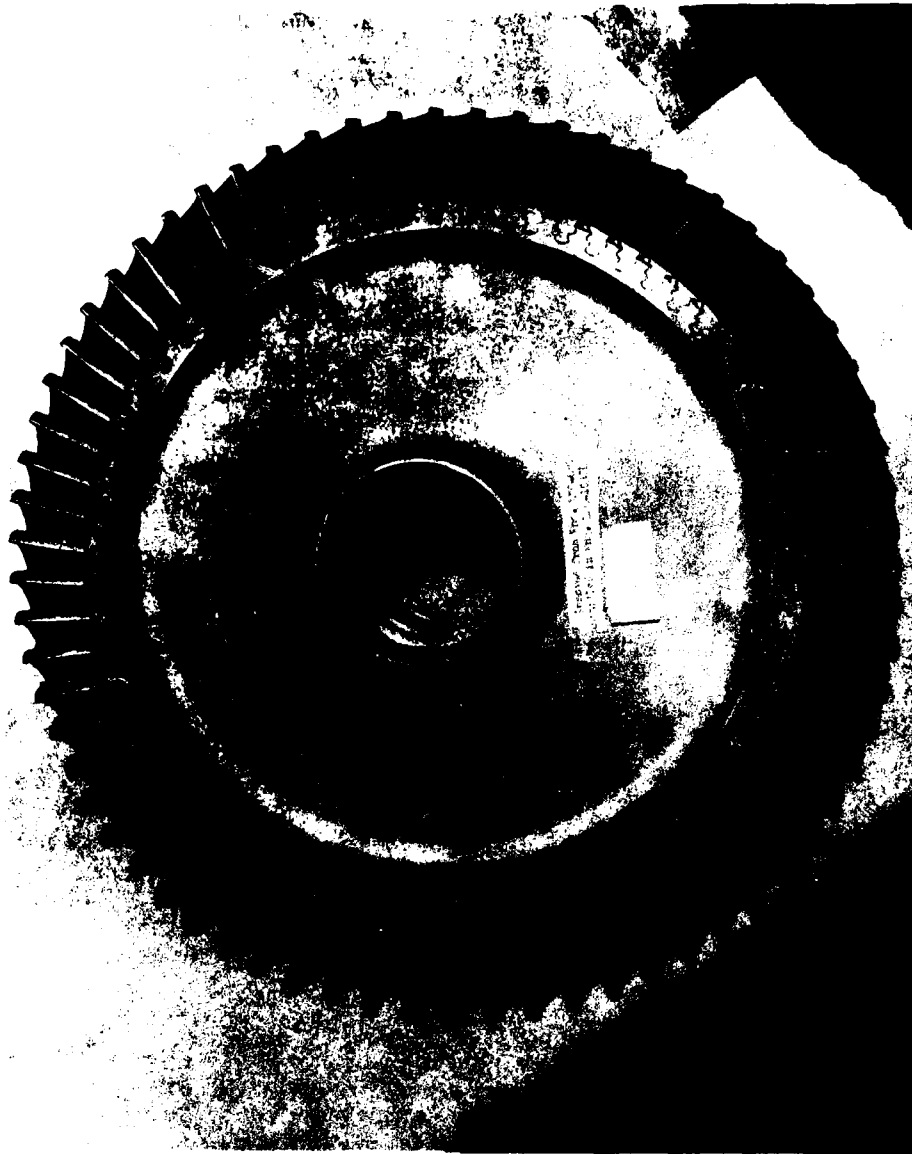
b. Gas Producer Turbine Wheel (Thicker-Walled Blades), FSN 2840-022-7501, P/N 1-100-490-06. The gas producer turbine wheel (figure 3) accumulated 192.7 hours in engine S/N LE-09753. After the engine was removed due to FOD, the turbine wheel was fluorescent-penetrant inspected and no defects were found. The gas producer turbine tip clearances were:

Figure 3. Gas producer turbine wheel, 192.7 operating hours.

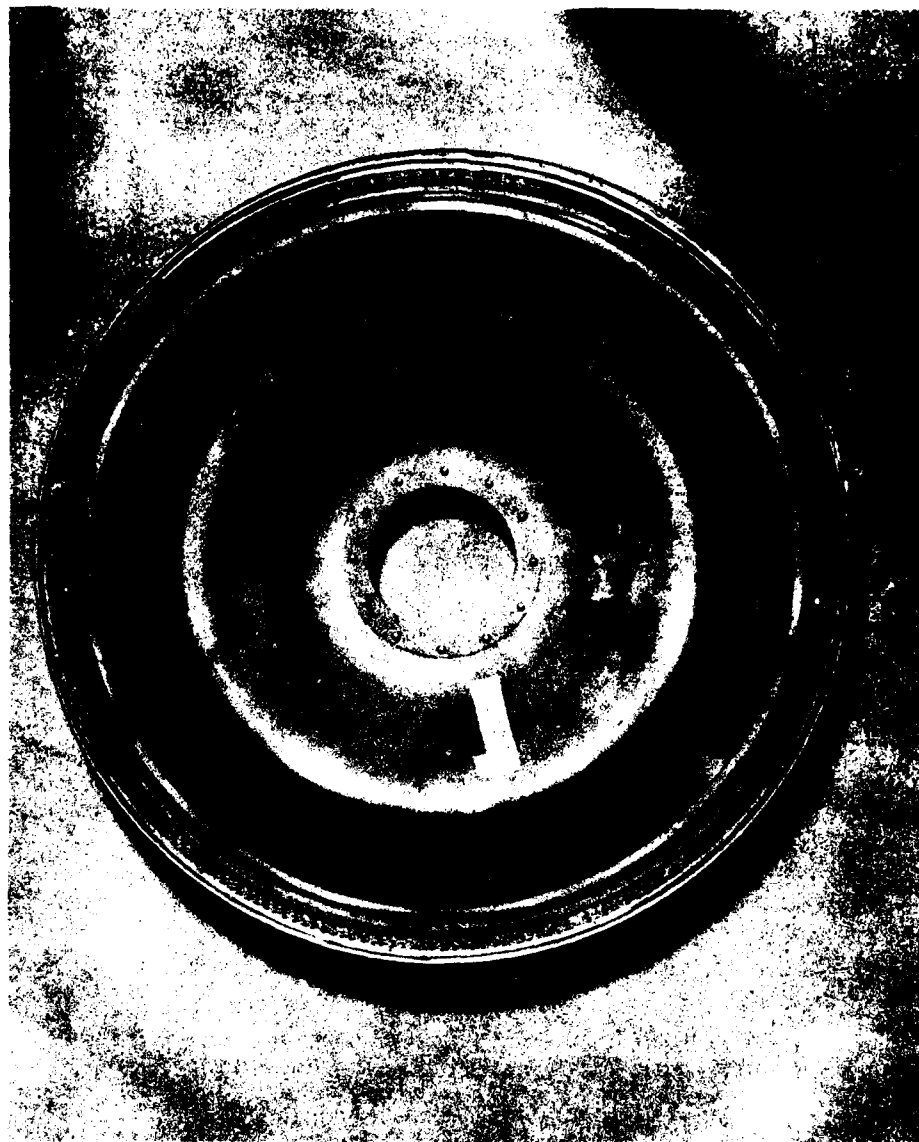
g. Power Turbine Nozzle (Depot Repairable), FSN Not Available, P/N 1-140-420-04-E (EXP-7710-02). The power turbine nozzle (figure 11) accumulated 192.7 hours in engine S/N LE-09753 prior to the first inspection. Fluorescent-penetrant inspection revealed that eleven of the vanes had cracks in the vane-to-outboard shroud joint at the trailing edge (figure 12). The cracks varied in length from 0.031 to 0.062 inch. The nozzle was installed in engine S/N LE-10394 and accumulated 600.4 hours prior to the next inspection. This inspection revealed no additional discrepancies and the nozzle was installed in engine S/N LE-09109. After operating for 1200 hours, the nozzle was again inspected. Dye-penetrant inspection revealed that 18 vanes had cracks in the vane-to-outboard shroud joint at the trailing edge (similar to those shown in figure 12); 4 vanes had cracks in the vane-to-inboard shroud joint at the trailing edge; 20 vanes had cracks in the vane-to-outboard shroud joint at the leading edge; and 1 vane had a crack in the vane-to-inboard shroud joint at the leading edge. All cracks were within the field limits specified in TB 55-2800-200-30/1 dated 28 June 1966. On the basis of these facts, the new nozzle appears acceptable for use in the T53-L-11 engine.

Figure 11. Power turbine nozzle,
192.7 operating hours.

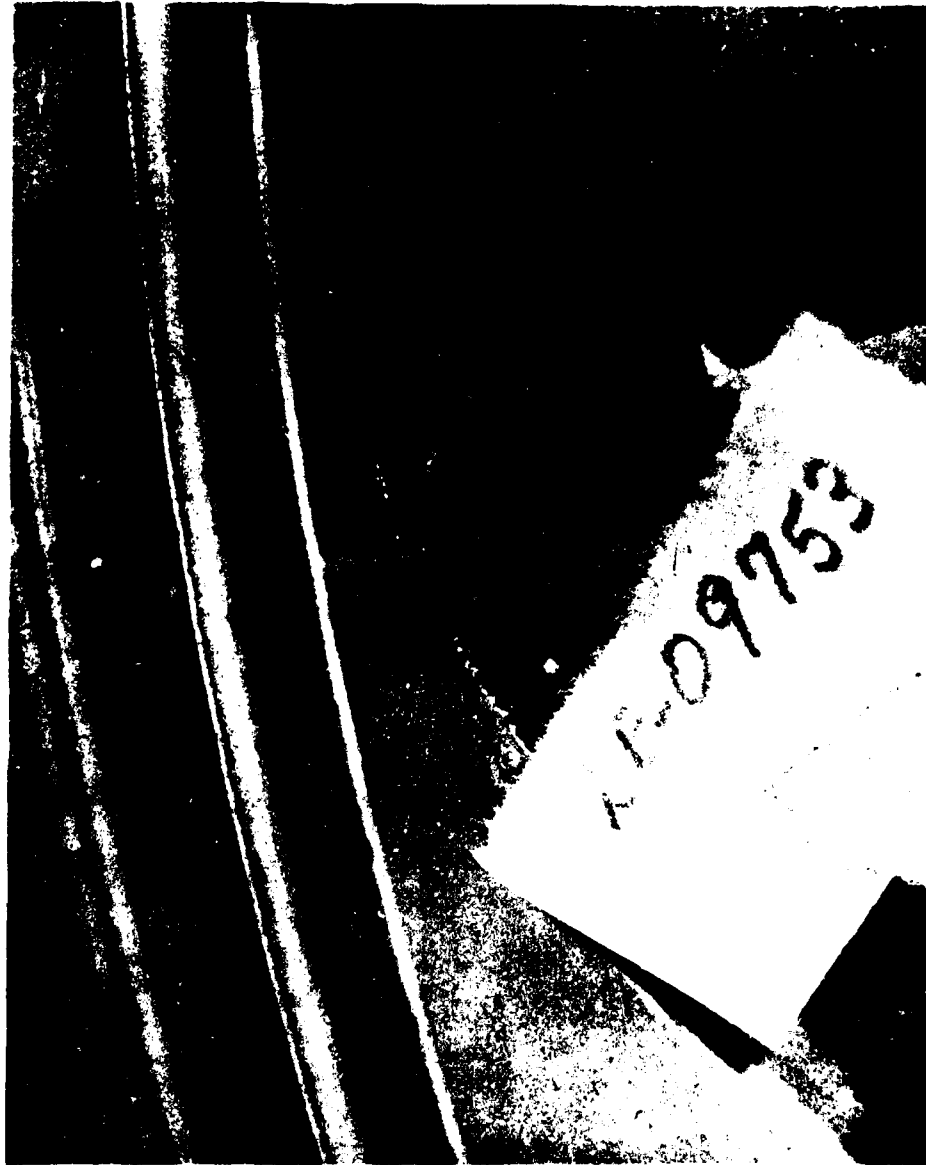
Figure 12. Cracks in vane-to-outboard shroud joint at trailing edge of power turbine nozzle, 192.7 operating hours.

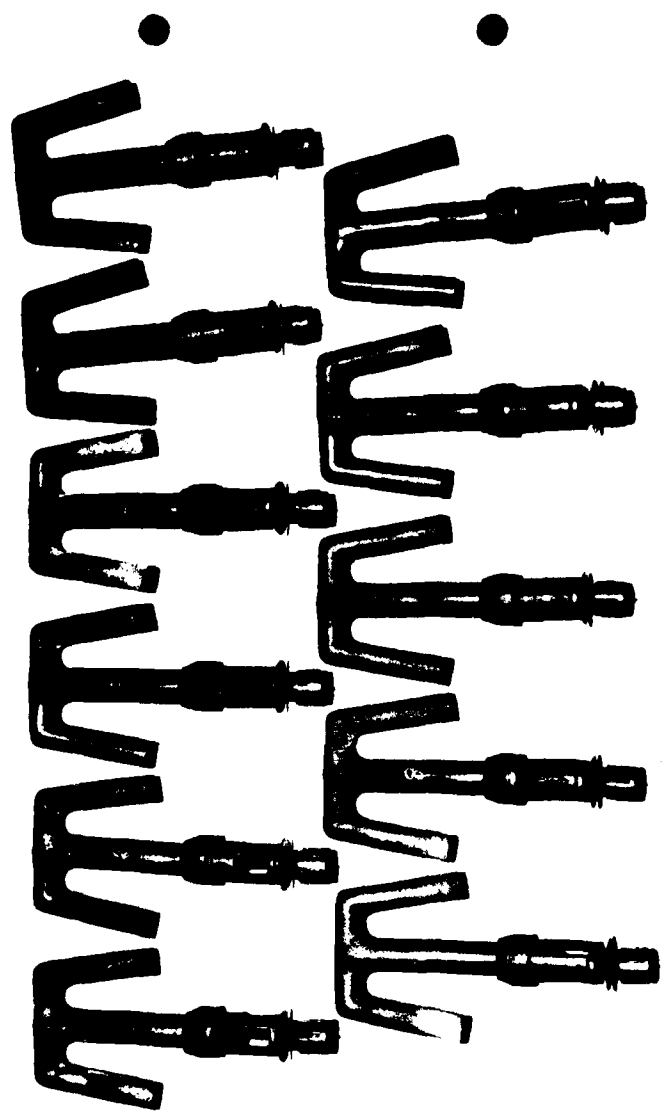
h. Fuel Vaporizers, FSN 2915-074-3369, P/N 1-130-590-02. The fuel vaporizers (figure 13) operated 192.7 hours in engine S/N LE-09753. Inspection revealed that one vaporizer had 1/16-inch cracks in two of the four welds that attach the cooling shroud to the vaporizer (figure 14), and another vaporizer had slightly damaged threads (figure 15). All vaporizers were considered serviceable and were installed in engine S/N LE-10394. After 600.4 hours of operation, the vaporizers were again inspected. Two vaporizers, numbers 2 and 4, were replaced

Figure 13. Fuel vaporizers,
192.7 operating hours.

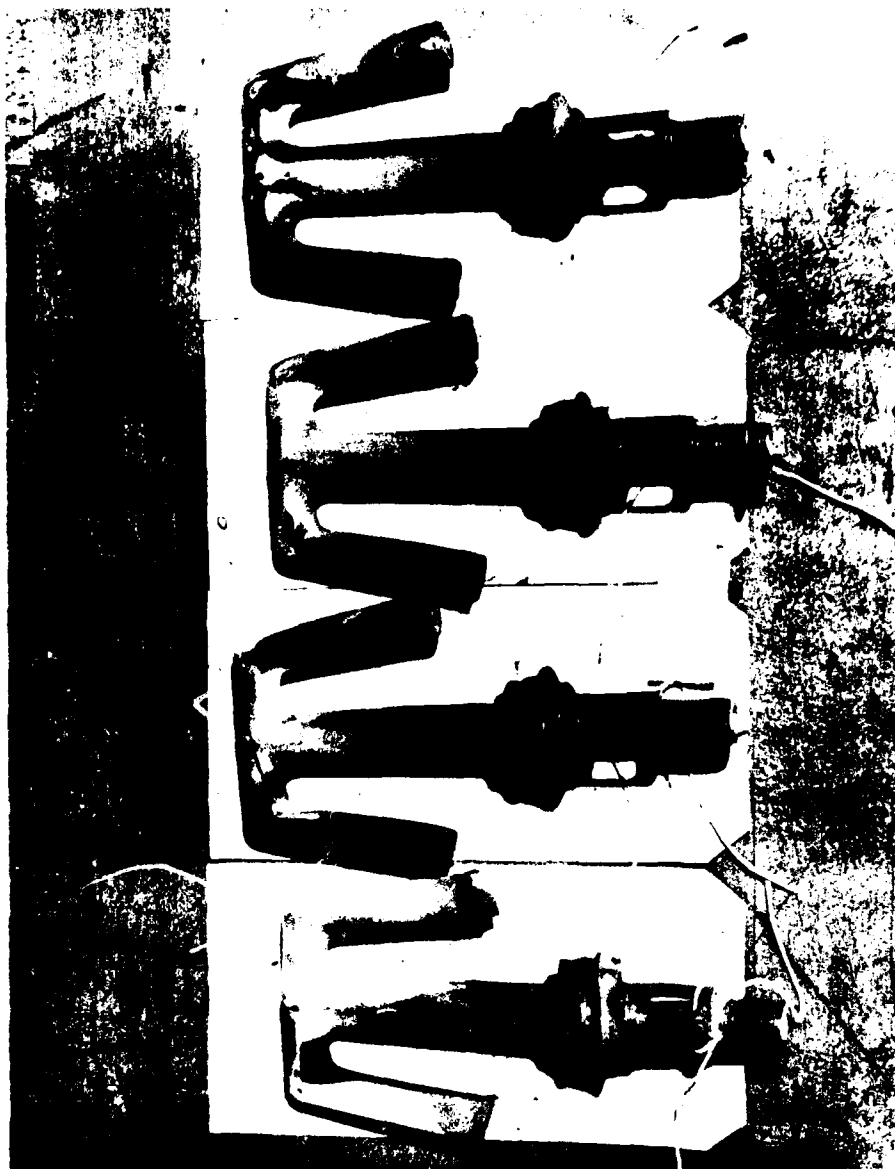
Figure 23. Four vaporizer seals broke loose from liner and jammed down on vaporizers, 1200.0 operating hours.
